# FIRE RETARDANT COATINGS OF TEXAS, LLC FIRE TEST REPORT

ASTM E2768-11 TESTING ON FX LUMBER GUARD / FX LUMBER GUARD XT

104055010SAT-005

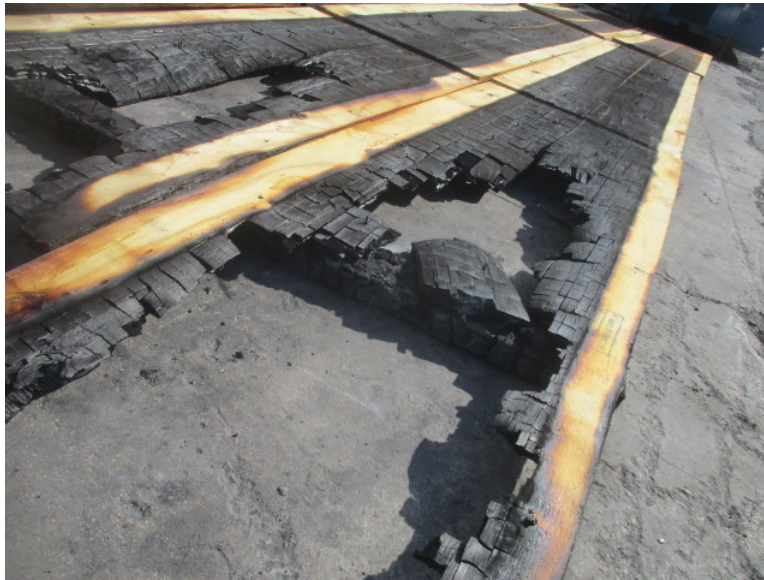
**Photo No. 5**

**Exposed Surface of the Test Specimen (Post-test)**

<b>TEST OBSERVATIONS</b>	
Ignition Time	2:19
Fallout Observed	16:52
After Flame	0:60+
Observations After the Test:	
0 – 6 ft.	The specimen was consumed.
6 – 12 ft.	The specimen was heavily charred and cracked.
12 – 15 ft.	The specimen was charred and cracked.
15 – 24 ft.	The specimen was heavily discolored.

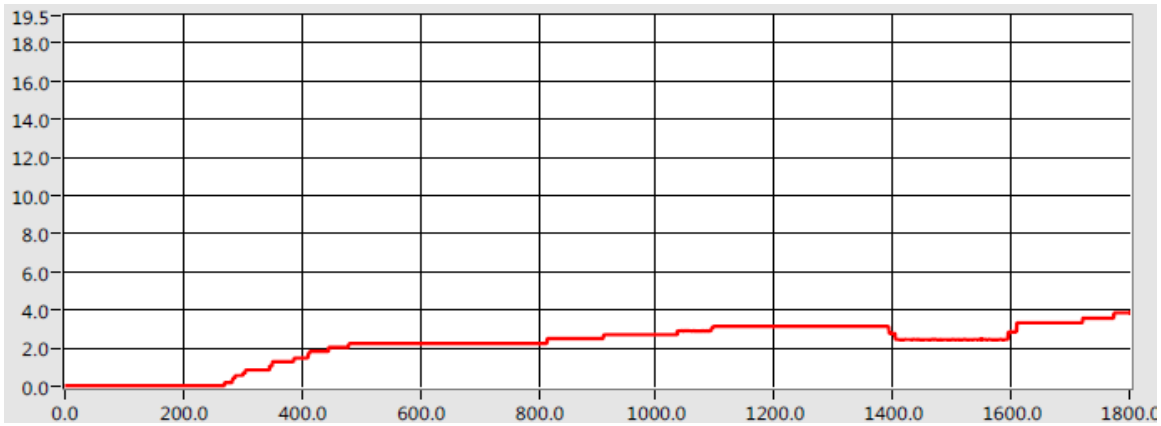
Graph No. 1 - Flame Spread Distance Versus Time

<b>TEST DATA</b>	
FSI (unrounded)	4.6
SDI (unrounded)	53.18
FS * Time Area (Ft * Min)	8.9
Smoke Area (% * Min)	42.55
Total Fuel Burned (Cubic Ft.)	124.68
Max Flame Front Advance (Ft.)	3.8 (8.3 ft. beyond burners' centerline)
Time to Max Flame Front (sec)	1774
Max Temp At Exposed T/C (°F)	579
Time To Max Temp (sec)	1796

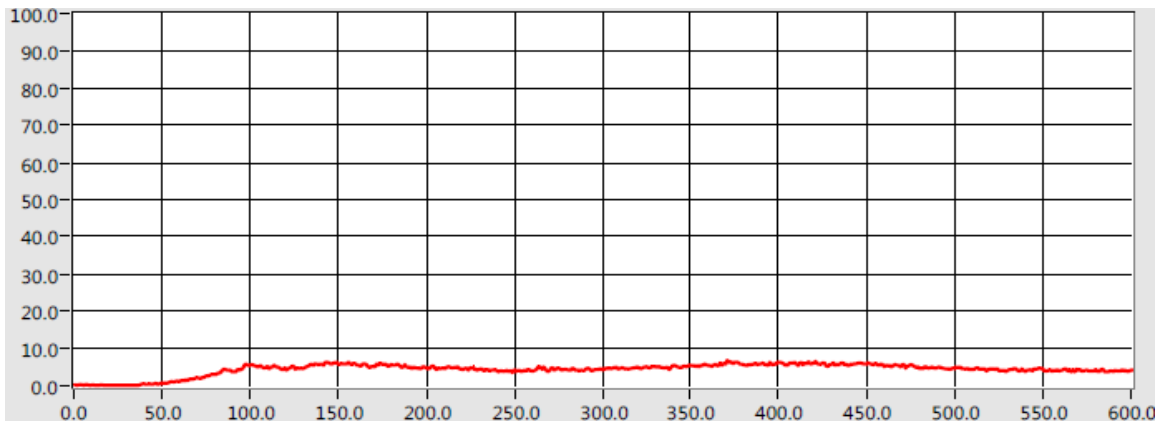
Graph No. 2 - Light Obscuration Versus Time

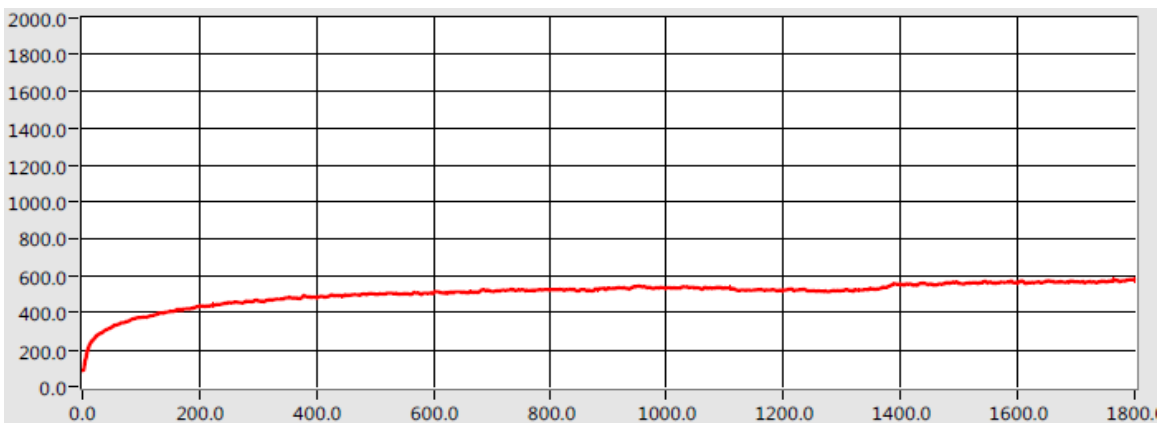
Graph No. 3 - Tunnel Air Temperature Versus Time
